**Maxwell Air Force Base/Gunter Annex
Architectural Survey, 1996**

1. Survey Number: 101-Maxwell-181 2. Building Number: 1208
3. Historic name(s): Barracks
4. Common name(s): Administration Office, Non-AF
5. Address/location: 810 Willow St., Maxwell Air Force Base
- City: Montgomery County: Montgomery
6. Photograph Number: Roll: 20 Frame: 1-2
7. Section/Township/Range: S3/T16N/R17E
8. Quadrangle Sheet: Montgomery North
9. UTM Coordinates: Easting: 560254
Northing: 3583937
10. NRHP Eligibility: Eligible
11. Category: Building
12. Historic use(s): Troop Housing
13. Current Use(s): Office

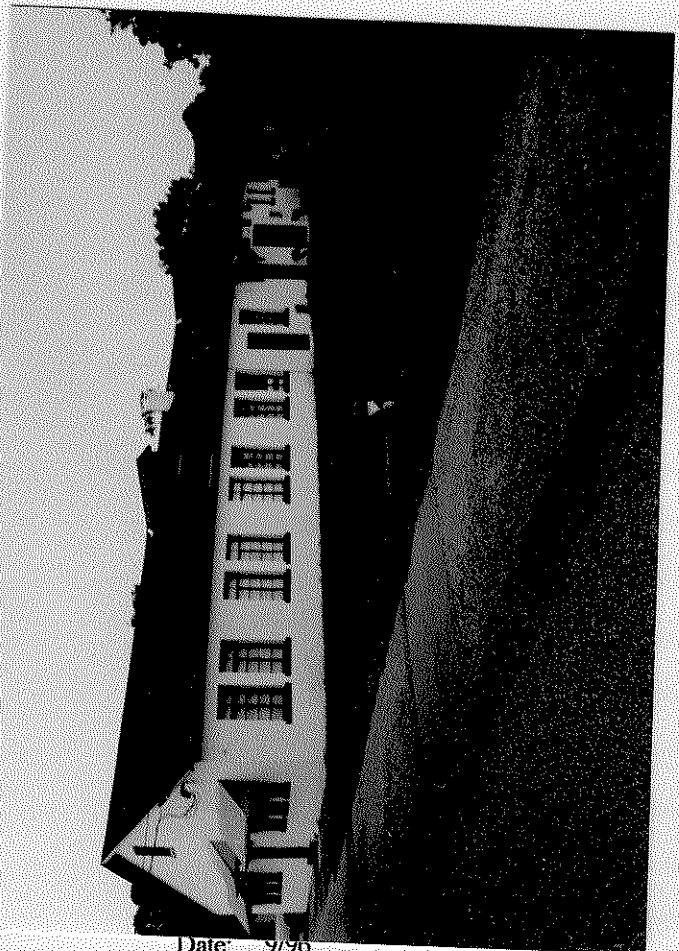
- A) Overall Shape: Rectangular
- B) Internal Plan: unknown
- C) Facade: symmetrical
- D) Depth: 2 rooms
- E) Height: 1 story
- F) Foundation: concrete
- G) Roof Shape: end gable
- H) Roof Material: asphalt shingle
- I) Wall Construction: hollow tile
- J) Wall Surface: stucco
- K) Chimney Type: NA
- L) Chimney Material: NA
- M) Doors: 1 single
- N) Porch Height: NA
- O) Porch Width: NA
- P) Porch Roof Type: NA
- Q) Porch Description: NA
- R) Windows: paired casement

18) **Additional Descriptive Comments:** Central door at end. 3 casement windows on each side. Paired casement windows along the long side. 3 narrow louvered dormers on each roof, appear to be original. 2 side doors on long side covered by engaged shed roof supported by brackets.

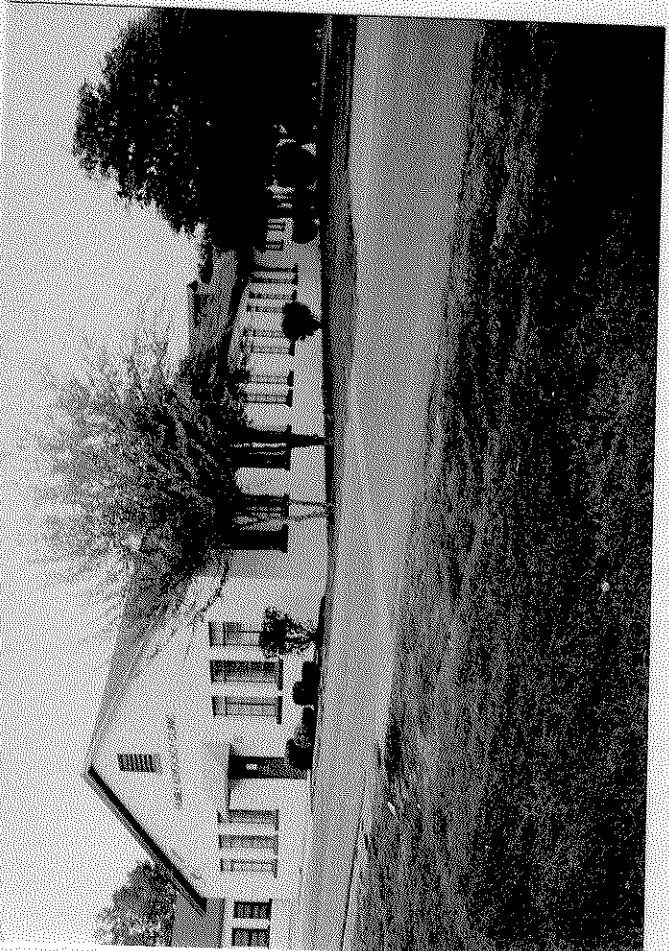
- A) Overall Shape: Rectangular
- B) Internal Plan: unknown
- C) Facade: symmetrical
- D) Depth: 2 rooms
- E) Height: 1 story
- F) Foundation: concrete
- G) Roof Shape: end gable
- H) Roof Material: asphalt shingle
- I) Wall Construction: hollow tile
- J) Wall Surface: stucco
- K) Chimney Type: NA
- L) Chimney Material: NA
- M) Doors: 1 single
- N) Porch Height: NA
- O) Porch Width: NA
- P) Porch Roof Type: NA
- Q) Porch Description: NA
- R) Windows: paired casement

18) **Additional Descriptive Comments:** Central door at end, 3 casement windows on each side. Paired casement windows along the long side. 3 narrow louvered dormers on each roof, appear to be original. 2 side doors on long side covered by engaged shed roof supported by brackets.

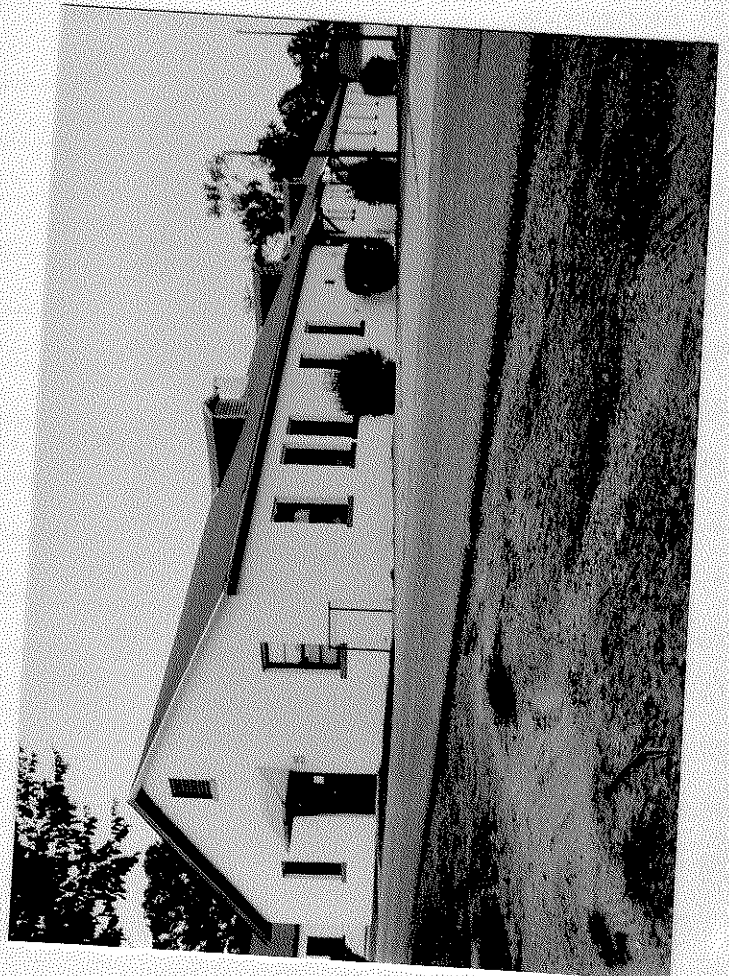
- A) Overall Shape: rectangular
- B) Internal Plan: central hallway
- C) Facade: symmetrical
- D) Depth: 2 rooms
- E) Height: 1 story
- F) Foundation: concrete
- G) Roof Shape: end gable
- H) Roof Material: asphalt shingle
- I) Wall Construction: hollow tile
- J) Wall Surface: stucco
- K) Chimney Type: NA
- L) Chimney Material: NA
- M) Doors: 1 double
- N) Porch Height: NA
- O) Porch Width: NA
- P) Porch Roof Type: NA
- Q) Porch Description: NA
- R) Windows: Modern double-hung sash

18) **Additional Descriptive Comments:** Altered version of facilities 1208 and 1209; casement windows have been replaced with modern windows. Side doors and dormers kept the same. Low one-story section added to long side.

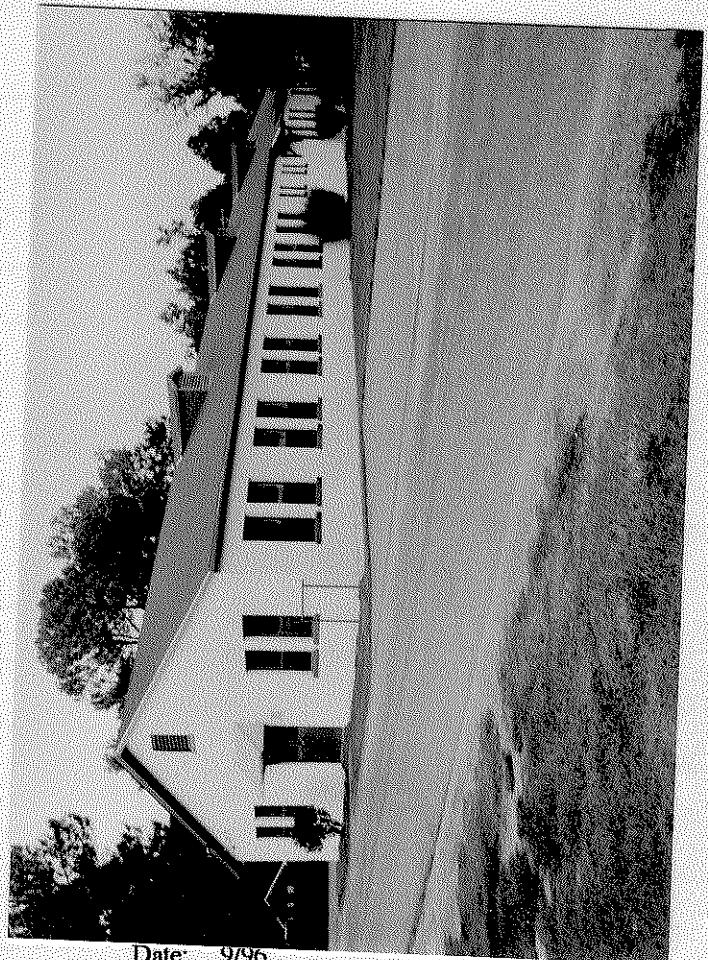
- A) Overall Shape: rectangular
- B) Internal Plan: central hall
- C) Facade: symmetrical
- D) Depth: 2 rooms
- E) Height: 1 story
- F) Foundation: concrete
- G) Roof Shape: end gable
- H) Roof Material: asphalt shingle
- I) Wall Construction: hollow tile
- J) Wall Surface: stucco
- K) Chimney Type: NA
- L) Chimney Material: NA
- M) Doors: 1 double
- N) Porch Height: NA
- O) Porch Width: NA
- P) Porch Roof Type: NA
- Q) Porch Description: NA
- R) Windows: Paired modern double-hung sash

18) **Additional Descriptive Comments:** Similar to building 1210 in which original casement windows have been replaced with modern double-hung windows. Original dormers remain. Side door filled in, though engaged shed roof remains.

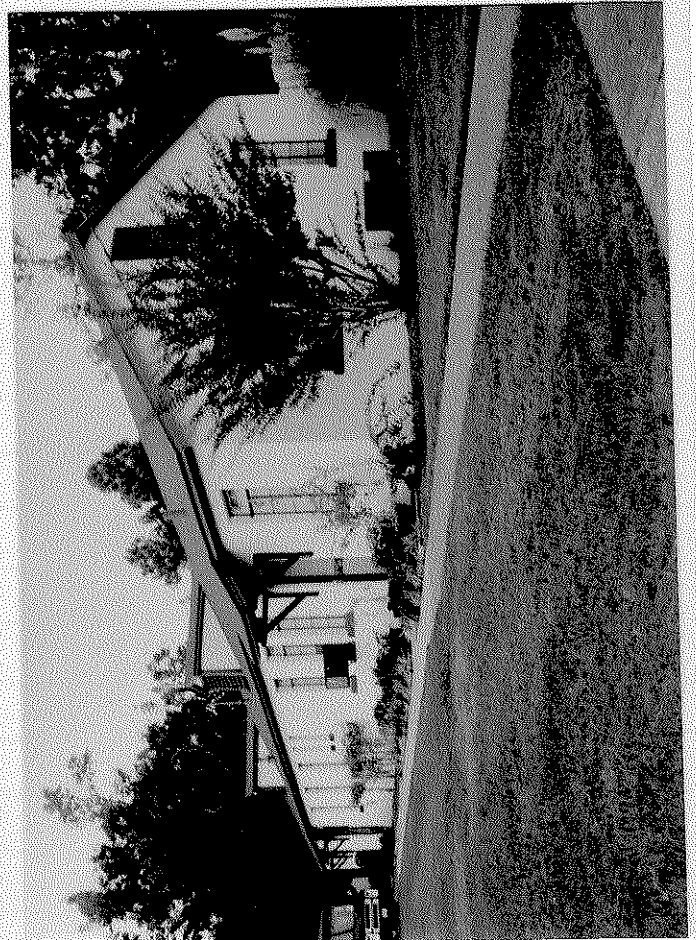
- A) Overall Shape: rectangular
- B) Internal Plan: unknown
- C) Facade: asymmetrical
- D) Depth: 1 room
- E) Height: 1 story
- F) Foundation: concrete
- G) Roof Shape: side gable
- H) Roof Material: asphalt shingle
- I) Wall Construction: hollow tile
- J) Wall Surface: stucco
- K) Chimney Type: NA
- L) Chimney Material: NA
- M) Doors: 1 double, 1 single
- N) Porch Height: NA
- O) Porch Width: NA
- P) Porch Roof Type: NA
- Q) Porch Description: NA
- R) Windows: Casement

18) **Additional Descriptive Comments:** No clear front entrance; 3 doors along long side, each under an engaged shed roof with brackets. Apparently original windows; 2 narrow louvered dormers apparently original. 1 door along long side filled in.
